Introduction

This technical brief highlights a recently discovered performance anomaly with the HI7190/1. The problem occurs when the digital code for the notch filter is programmed within certain frequencies listed in Table 1 (assuming a 10MHz clock). We believe the error is caused by the calibration logic and the digital notch code NOT the absolute frequency. The error is seen when the user applies mid-scale (0 volt input, Bipolar mode). With this input, the expected digital output should be mid-scale (800000_H). Instead, there is a small probability, of an erroneous negative full scale (000000_H) output.

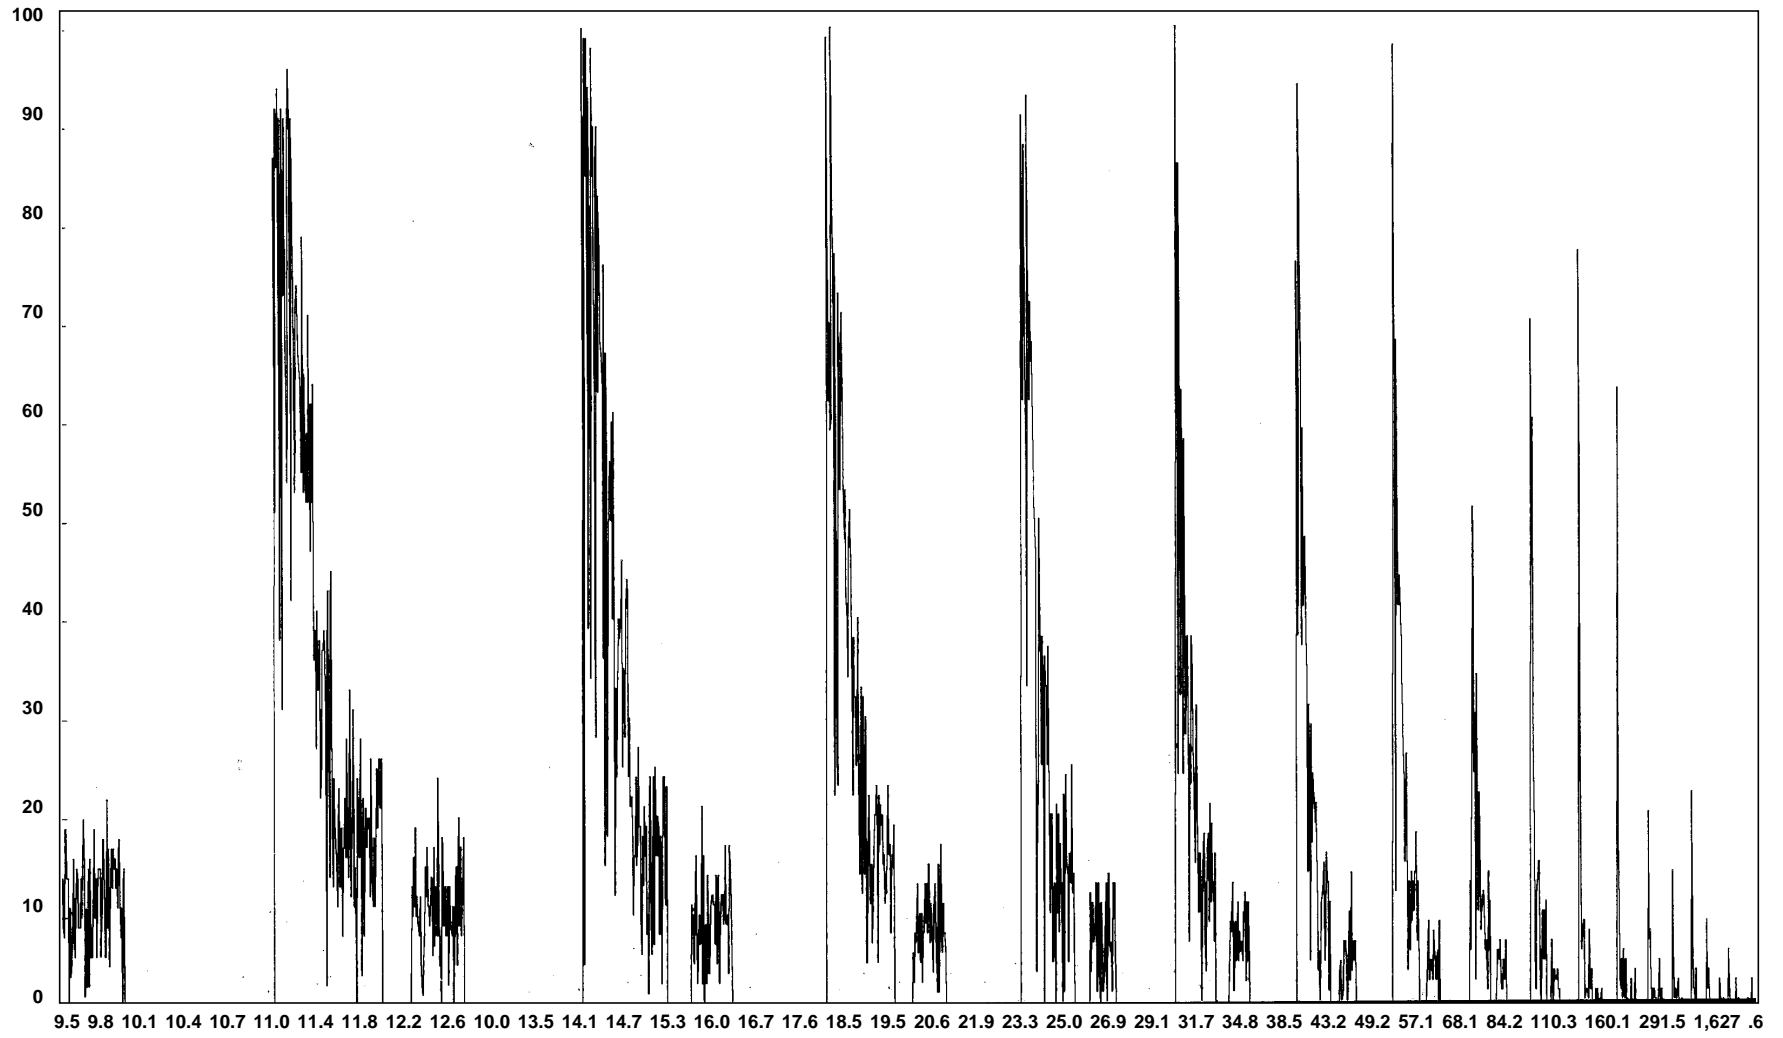
FIGURE 1. NEGATIVE FULL SCALE ERRORS PER 100 COVERSIONS

To characterize the performance anomaly, we tested the device at each of the possible notch frequencies. With an input voltage of mid-scale (0v), 100 hundred conversions were recorded. The frequencies which exhibited at least one negative full scale (NFS) output code are found in table 1. In addition, graph 1 shows the number of erroneous conversions observed at each frequency. Reviewing the graph indicates, the higher the conversion frequency, the lower the probability of observing the NFS error. This is due to the reduced probability of the output code being exactly mid-scale given the noise. For example, with a 10 hertz notch only the lower few data bits are toggling, therefore; there is a high chance (>25%) of hitting exactly mid-scale. With a high conversion rate of 1953 hertz the lower 11 bits are toggling, therefore; there is a very low chance of hitting the exact mid-scale code.

The present revision of the production silicon operates as designed and meets all other documented specifications. It is highly recommended to avoid the notch frequencies detailed in table 1 based on this limited experimentation. There may be additional notches which exhibit the negative full scale errors which are not identified in table 1. If these frequencies are absolutely needed, the master clock can be increased or decreased slightly ($\pm 10\%$) to accommodate the desired frequency, since the problem is related to the control register programming and not the absolute frequency. In addition, the user may desire to screen the NFS error in software. The user should evaluate their application to determine their sensitivity to this possible anomaly given the likelihood of the input being exactly mid-scale, bad notch frequency and output code hitting exact mid-scale.
